Whitemans Creek Water Conservation & Drought Contingency Planning

Water Adaptation Management and Quality Initiative

Prepared by Hajnal Kovacs, GRCA,
on behalf of the Brant County Federation of Agriculture
January 2015

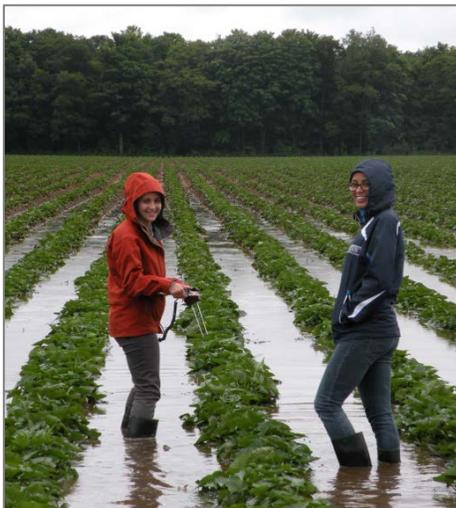
Figure 2 Flooding after a heavy rain event in a sweet potato field (from the left Courtney Clark and Nadine Gill, photo courtesy of Janet Licskai, OFA)

There is a lot more to soil moisture than saying the field is "dry" after a week of no rain or saying it is "wet" after a rain event that saturates a field (Figure 2). Monitoring soil moisture helps accurately determine when and how much irrigation is needed so farmers do not irrigate too early or wait until the plants are already showing sign of water stress (**Kovacs, 2013**).

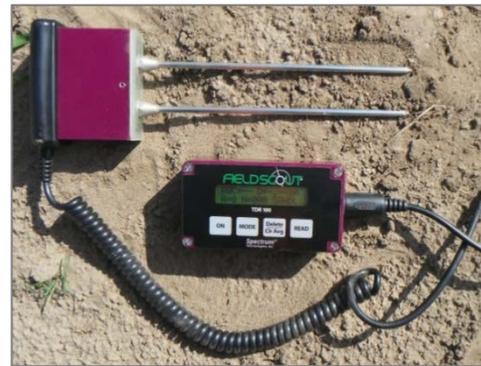
Monitoring with a portable FieldScout TDR100 soil moisture meter (Figure 3) was offered three times a week to interested irrigators. Readings were collected at the same time of day, from June through August, analyzed and communicated with irrigators through a weekly soil moisture report. The focus of the report was a graphical presentation of the soil moisture. This graph includes two important reference lines: a recommended "start irrigation" line when the water deficit is 0.65" (blue line) and a "permanent wilting point" warning line when the water deficit is 1.3" (red line). The daily rainfall collected at the Burford Tree Nursery was also presented in these graphs for reference (blue columns).

Figure 3 FieldScout TDR100 Soil Moisture Meter with 8" probes.

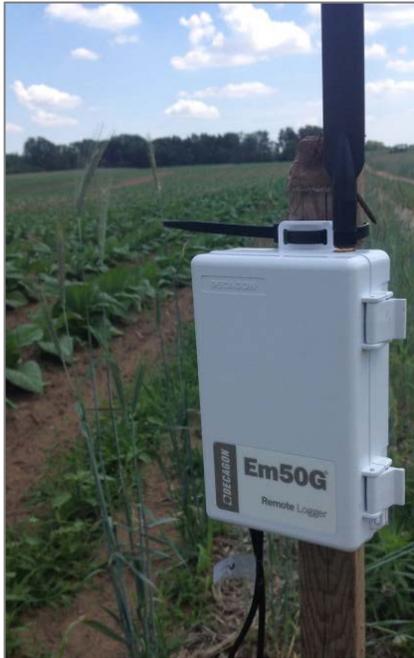
In order to pilot some continuous soil moisture monitoring, a remote Decagon Em50G soil moisture sensor (Figure 4) was offered to one of the interested irrigators located in the northern part of the subwatershed. This remote sensor not only granted a more detailed understanding of their continual soil moisture but it also saved travel time for the field technician who conducted FieldScout monitoring for the other farms. The remote sensor sends the information it collects to computers through a wireless connection. Anyone with the login information can access the website that hosts the live data of the soil moisture probes. The weekly or entire data set can be downloaded from this website and the weekly data is automatically displayed in a graph. Decagon sells additional software, DataTrac 3, to analyze soil moisture and environmental measures that were used to create the graphs presented in the weekly reports to the irrigator (Appendix Figure 29). The focus of this report was also a graphical presentation of the soil moisture. This graph includes the same two important reference lines as the TDR100 weekly soil moisture reports: a recommended "start irrigation" line (blue line) and a "permanent wilting point" warning line (grey line).

Figure 4 Decagon Em50G Remote Sensor on a tobacco field.

A tobacco farmer who had his field monitored with the TDR100 in 2013 was interested in comparing the two technologies and volunteered to have his field monitored. Staff set up an Em50G sensor with 2 probes at depths of 10" and 20" in his tobacco field. Beginning in June, readings were collected every hour and analyzed weekly for a soil moisture report to be delivered to the irrigator.

The soil moisture reports presented the Volumetric Water Content (VWC) displayed in volume of soil water per unit of total volume (m^3/m^3). Since the relevant unit that irrigators use to determine how much water to apply is inches, staff manually determined at which VWC values the PAW equalled 50% and the water deficit equalled 0.65". As determined with the TDR100, this is when irrigation is recommended to commence. We determined that when the soil moisture is 15% the water deficit is 0.65" and irrigation was recommended to start, and when soil moisture is 10% the water deficit is 1.3" and the permanent wilting point may be reached.

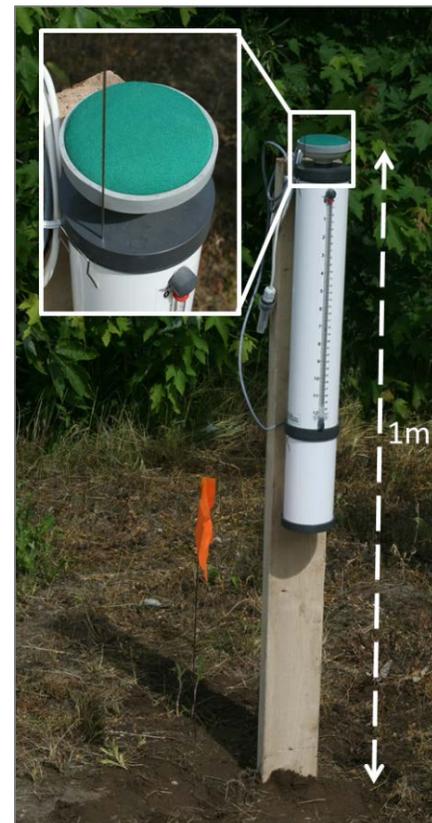
Keeping track of Potential Evapotranspiration (PET) with an Evapotranspiration Gauge (Figure 5) is another way to determine *when* and *how much* to irrigate. PET is the amount of water a crop potentially transpires combined with the water potentially evaporated from the soil and plant surface. PET can be converted to crop stage specific readings by multiplying the reading by the applicable crop factor (*see omafra.gov.on.ca for details*). PET helps quantify how much water leaves a field and can be translated to the amount of water that needs to be applied back to the field through irrigation to maintain successful crop growth. Actual evapotranspiration depends on climate, solar radiation, crop cover and the amount of moisture available in the soil.

Figure 5 Evapotranspiration gauge set up at the Burford Tree Nursery.

Just like the soil moisture report recommendations, when the PET reading reaches 0.65”, we recommended beginning irrigation. For a drip tape system, irrigation should begin even earlier when PET equals 0.4”. If an irrigation event applied the amount of water that was evapotranspired then assume the field is at capacity and start adding up the PET values once again until it reaches the value that triggers irrigation to start. When using PET values posted online take into account where and how far away the gauge is located.

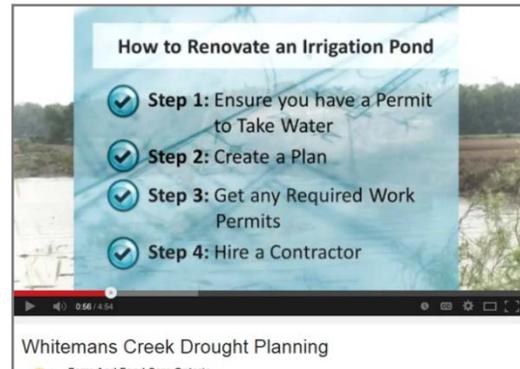
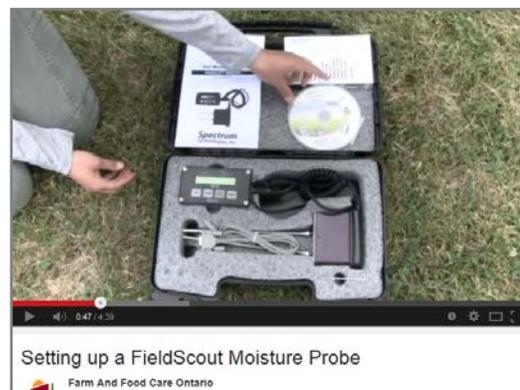
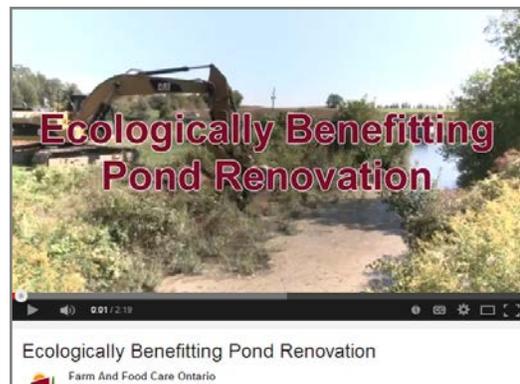
Figure 9 Farm and Food Care created YouTube videos of the steps involved in renovating a pond (top), setting up a FieldScout TDR100 soil moisture probe (middle), and the ecologically benefits of pond renovations (bottom) in 2014.

The success of these 2013 videos led to the production of three new YouTube videos in 2014 (Figure 9). The first was created to highlight the [steps in planning a pond renovation](#) as part of a drought contingency plan. Often landowners are not aware of *all* of the steps they should take, or the order in which to take them, to ensure they abide to all applicable regulations when planning a pond renovation.

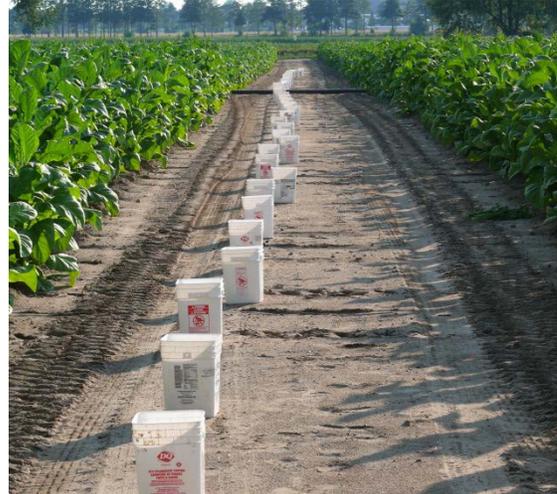
Figure 10 Irrigation assessment catch buckets (Photo courtesy of Rebecca Shortt, OMAFRA)

On July 25, 2014, the travelling gun irrigation system (Figure 11) of a Brant County farmer was assessed. Catch buckets were set out along the spread of the system to assess its Distribution Uniformity lower quarter (DUIq) (Figure 10). Ideally the DUIq is higher than 0.60. Assuming overlap on the edge rows, staff determined the DUIq of this travelling gun to be 0.88, which is excellent. The range of depth of water applied across the field was between 0.9” to 1.5” with an average depth of 1.1” (Figure 10). The irrigator was applying 1.0” of water so his system delivered just the right amount with an excellent distribution across the land. For more detail on the methods, please refer to “Irrigation Assessments” Appendix 2 of *Kovacs (2013)*.

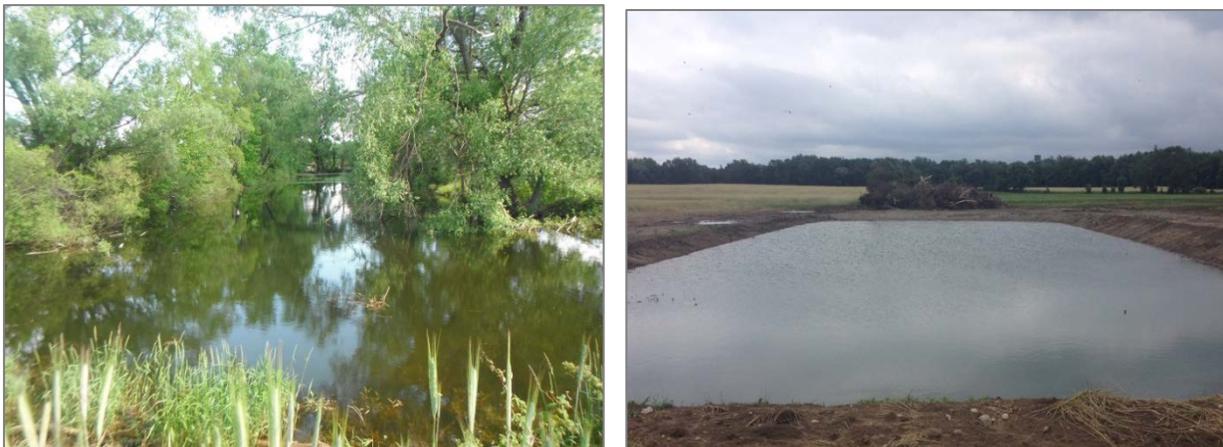
The landowner owns a large irrigation pond in the center of her tobacco field that had not been used for several decades and it had lost its recharge capacity. The pond used to be the primary irrigation source but the recharge rate diminished from the lack of pond maintenance. The alternative, and now primary, irrigation source is Whitemans Creek which sits at the back of the pond about 200 meters away. A GRCA work permit was acquired prior to starting this renovation. By cleaning out and deepening this pond we increased the water storage and exposed new seeps into the pond that can once again help recharge the water level (Figure 12). Removing the old willow trees around the edges of the pond reduces the amount of litter that will fall into the pond (helping improve water quality) and leaving more water for irrigation. The landowner is investigating various tree and shrubs species that she could plant around the pond to help stabilize the banks. The landowner has had an active PTTW for Whitemans Creek for several years and will be amending it to add this pond to her PTTW as a secondary source. She will not be changing her overall takings but will use the pond as her primary irrigation source and resort to Whitemans only if the pond is not sufficient. This irrigator now has the opportunity to become an “offline” irrigator, using groundwater as the primary irrigation source, which will reduce the pressure on Whitemans Creek in times of low water.

Figure 12 An unused 1960s irrigation pond before (left) and after clean up (right).

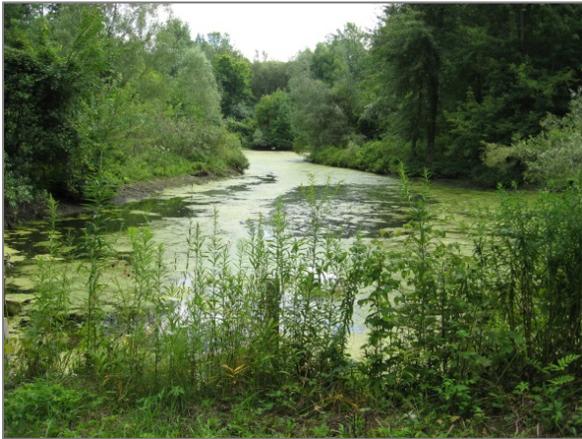
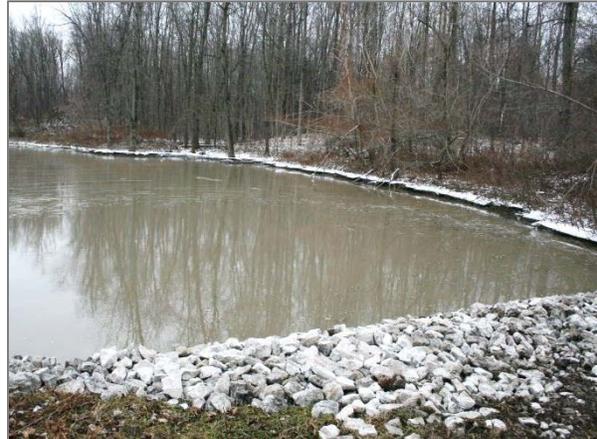
The landowner owns a large irrigation pond which is the primary irrigation source for 85 acres of corn. 37 acres of corn are irrigated via sub-surface drip (installed in 2014), while the remaining 48 are irrigated via overhead travelling guns. The landowner has a PTTW for this pond, and another PTTW for a surface water taking from Horner's Creek. The pond did not quite provide the needed supply to irrigate the 85 acres of corn, particularly during drought, and the landowner has laid overland pipe from Whiteman's Creek to his main line to draw sufficient water to irrigate. The pond was originally built 20 years ago and had suffered erosion issues and slumping on the north end which had filled in the pond and diminished its capacity. The pond recharges after 12 hours. No expansion of the pond was deemed necessary and the pond was cleaned out to a depth of 12 feet to increase its capacity (Figure 13). Rip rap was placed at the north end of the pond to mitigate the slumping and achieve a preferred 3:1 slope. As a result of this work, the landowner agreed to divert 50% of his online water taking. If further drip-tape is installed in the next few years as planned, the landowner considers that he could likely agree to divert 100% of his water taking.

Figure 13 Irrigation pond before (left) and after clean up (right).

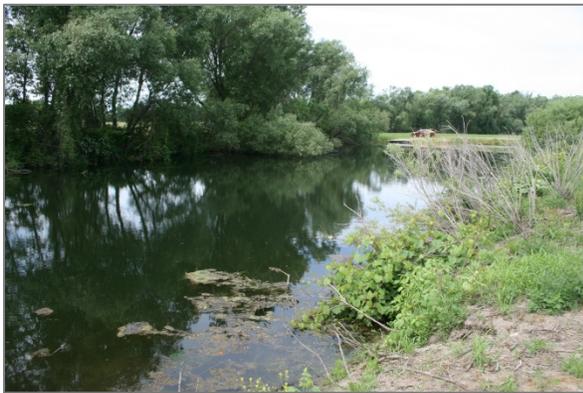
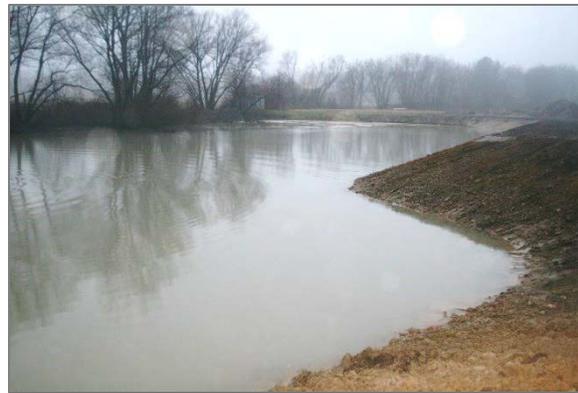
The landowner owns a large irrigation pond that the primary source to irrigate 30 acres of tobacco, but the pond suffered from poor recharge. During the summer, the pond could take up to three weeks to recharge. In time of drought, the landowner has laid overland pipe from his secondary Permit To Take Water from Whiteman's Creek in order to irrigate the tobacco. The pond was cleaned-out and expanded to expose a suspected spring on the northwest corner and a more gravelly deposit on the northeast corner (Figure 14 and Figure 15). The southern portion of the pond was not cleaned out; access was limited for this area because of a municipal drain and an established windbreak, but this area was also left unmaintained to allow a natural deposition of sediment and improve the slope stability. In addition, a tree and shrub buffer will be planted in spring 2015 along the northern and eastern edges of the pond to delineate the edge of the crop and to help maintain slope stability. This additional work was approved for funding from the Brant Rural Water Quality Program.

Figure 14 Irrigation pond before (left) and after clean up (right).

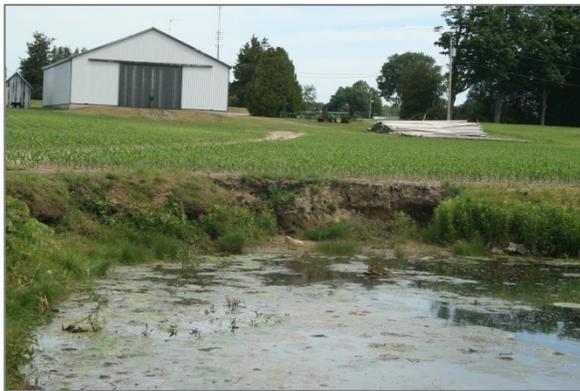
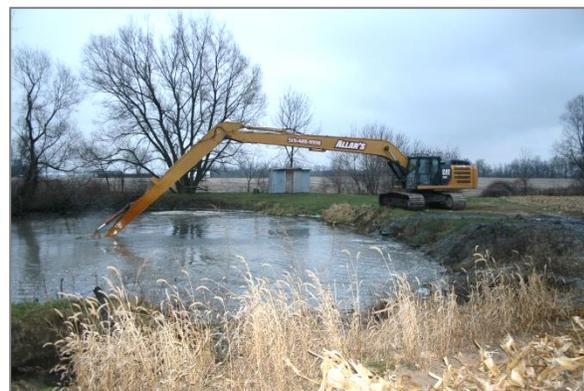
Figure 15 Irrigation pond before (left) and after clean up (right).

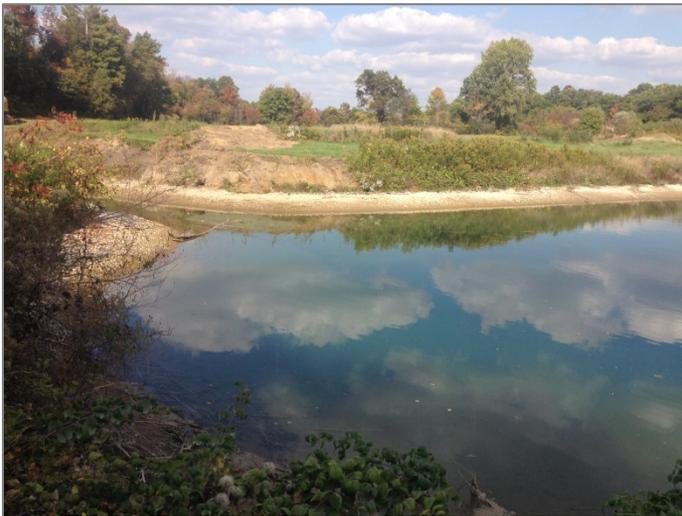
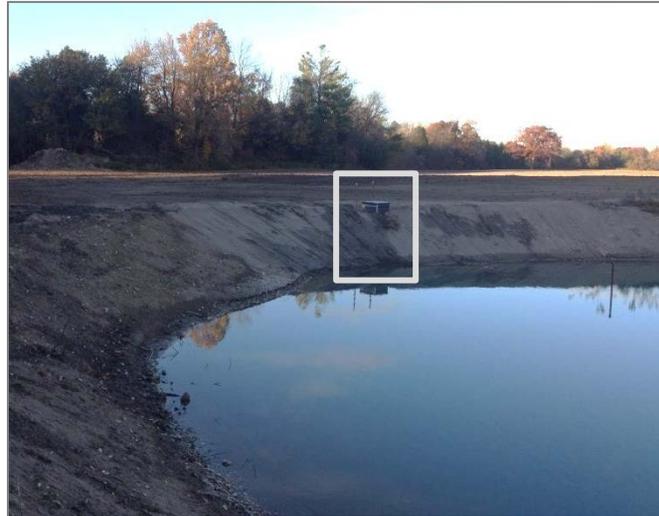
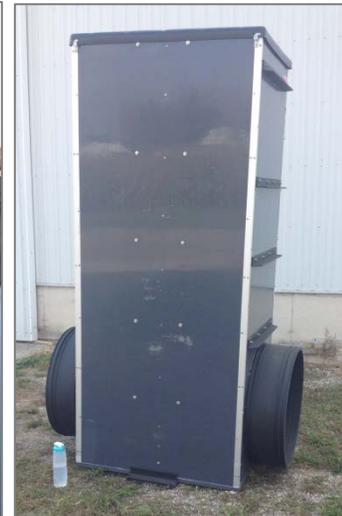
Figure 17 West pond outlet before (left) and after an 8' in-line water control structure was installed (center) (facing North East).

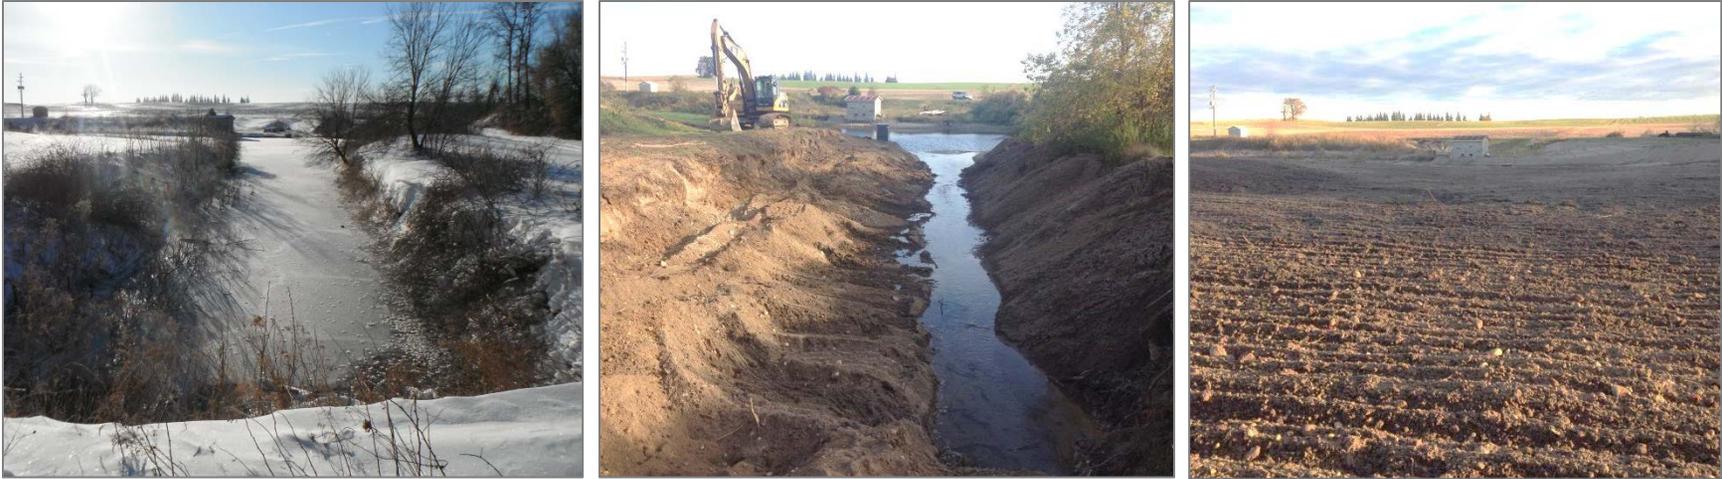
Figure 18 West pond outlet. Previous state (left), in progress (center), and after renovation (right) (facing South).

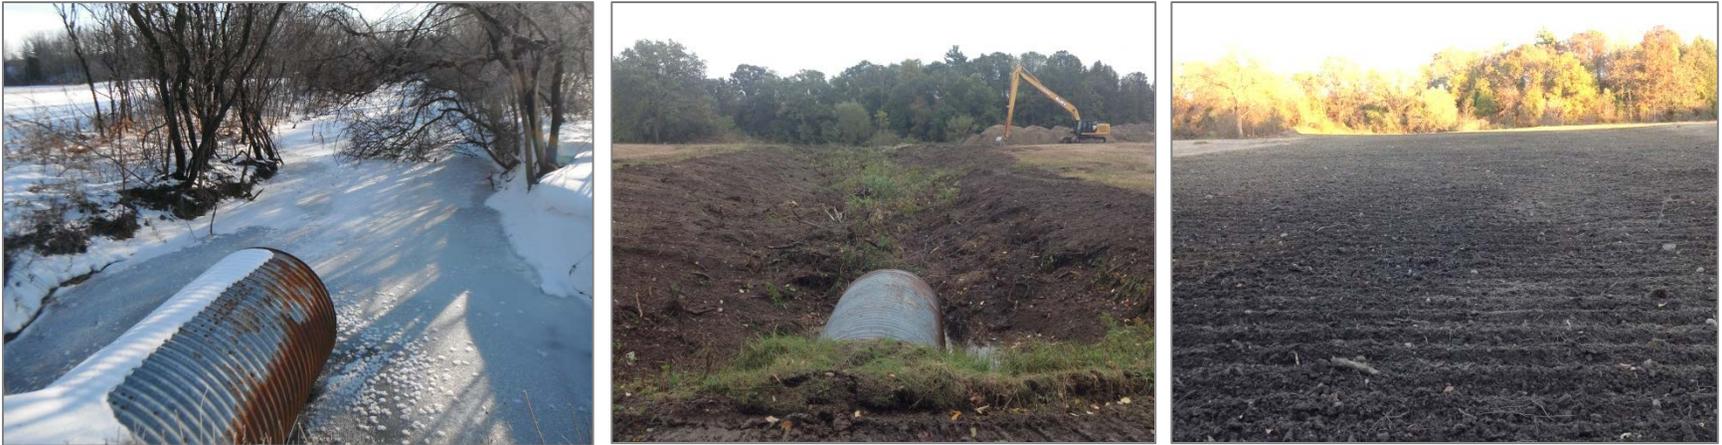
Figure 19 East pond outlet. Previous state (left), in progress (center), and after renovation (right) (facing South).

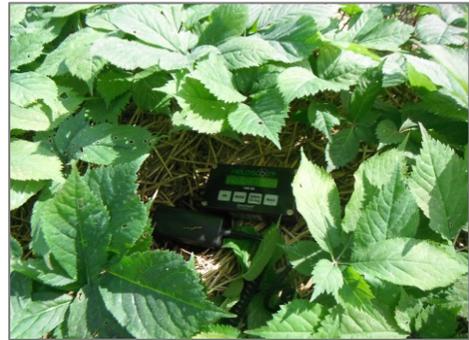
Figure 20 Monitoring soil moisture on two year old ginseng.

The soil moisture monitoring of seedling, 2 year old (Figure 20) and 3 year old ginseng fields are reported as daily field averages in Figure 21. The readings were determined by taking 9 measurements, in 3 different rows spaced 2 rows apart. Since ginseng is only irrigated in droughts, the soil moisture of ginseng fields is mostly influenced by rainfall events. Figure 21 in the Appendix clearly shows the relationship of soil moisture to rain in the 2014 growing season. For example, the rain events around June 25th significantly improve the water deficit for all of the fields from the June 23rd readings. The fields then began to dry out and the soil moisture dropped until the next rain event occurred.

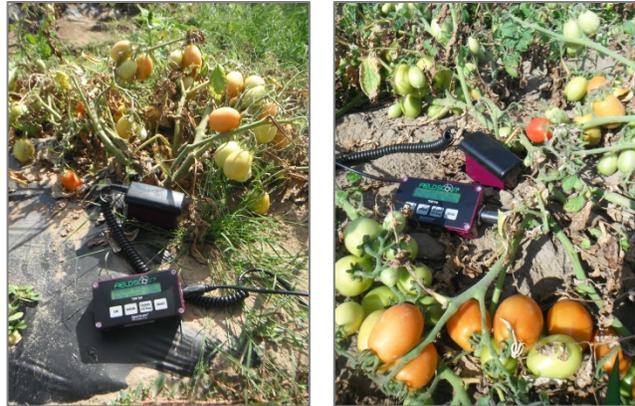
Figure 22 Tomatoes with plastic mulch (left) and without (right).

The soil moisture of mulched and non-mulched tomatoes was monitored once again in 2014 (Figure 22). Throughout the majority of the growing season, the tomato field without mulch fluctuated between the irrigation reference line and the permanent wilting point, with a few occasional rises towards field capacity following intense rains (Figure 23). At the beginning of August there was a rapid increase in water deficit following the extreme rainfall on July 28th, and it did not improve until the last few weeks of the month. From August 17th on, we see the climb back towards field capacity just in time for harvest time. Although this season was relatively ‘wet’, this field was kept closer to the permanent wilting point than to field capacity and could have been irrigated more often.

The tomato field with mulch was regularly between the irrigation reference line and the permanent wilting point for the 2014 season. The mulched fields had great improvements in water deficit in the last few weeks of August before harvest time and maintained low water deficit levels above the ideal drip irrigation reference line.

The 2014 data actually suggests that about two-thirds of the time the mulched field had a greater water deficit than the field without mulch - the opposite trend the 2013 data showed. This difference is likely due to the irrigation routine between the two systems (not irrigating with the drip system as frequently as with the overhead system). In addition, the mulched tomato plants were growing at a much faster rate than those without mulch which also contributed to a great water demand in the mulched fields. Once the mulched and non-mulched fields reached the same plant stage the differences between their water deficits became unnoticeable.

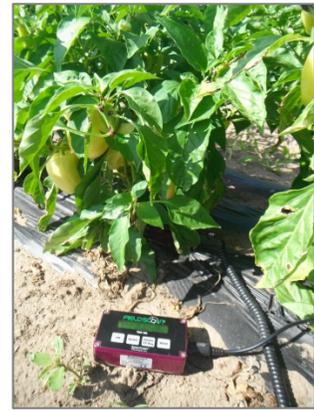
Figure 24 Peppers with plastic mulch.

The soil moisture in the mulched peppers (Figure 24) monitored in 2014 fluctuated between the ideal drip start and the permanent wilting point for the majority of the season and was influenced by trends in precipitation (Figure 25). Throughout the whole season the pepper field did not get too close to the permanent wilting point. Like the tomato fields, this field could have been irrigated more often as ideally you want to have the soil moisture above the irrigation reference line all season long. That being said, in the latter half of August the soil moisture was more consistently near the irrigation reference line, fluctuating on the other side of the line towards field capacity, which is an ideal trend. The last few weeks also maintained a water deficit close to zero which is excellent for harvest time.
