New Hamburg Flood Mitigation Study
Technical Memo No. 1:
Flood Damage Estimates

Prepared for:
Grand River Conservation Authority

Prepared by:
Matrix Solutions Inc.

Version 2.0
March 2020
Guelph, Ontario

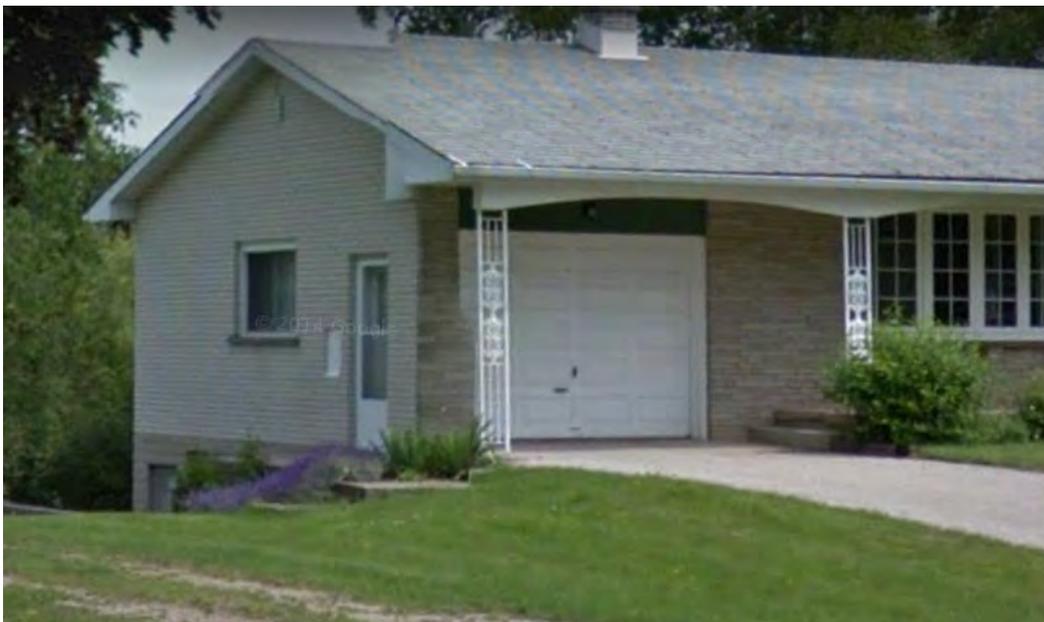
Graphic J **Ground Surface Representation for First-floor Elevation Recorded as MAX (Lot Drops off in Backyard)**

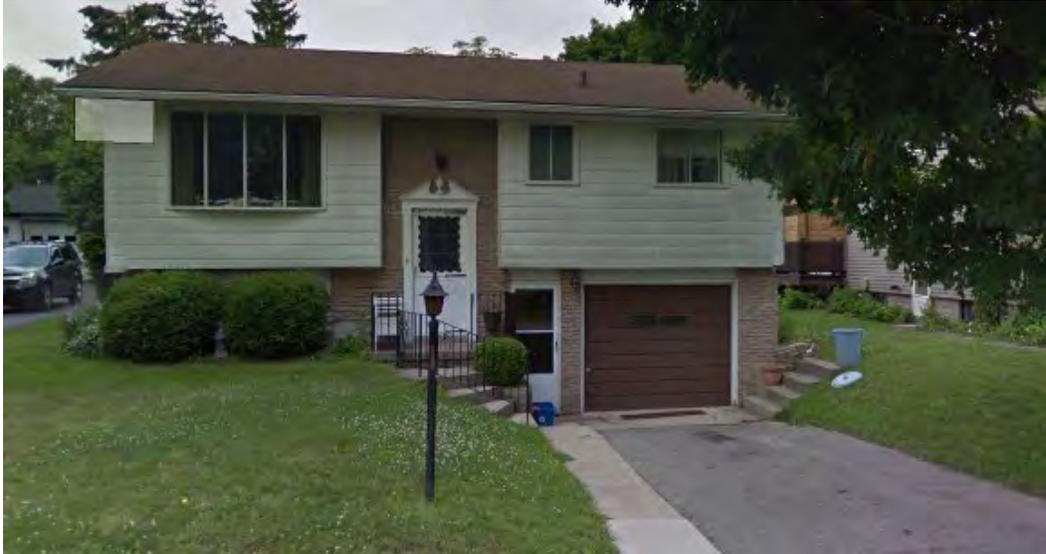
Graphic K Ground Surface Representation for First-floor Elevation Recorded as MIN (Plus Risers)

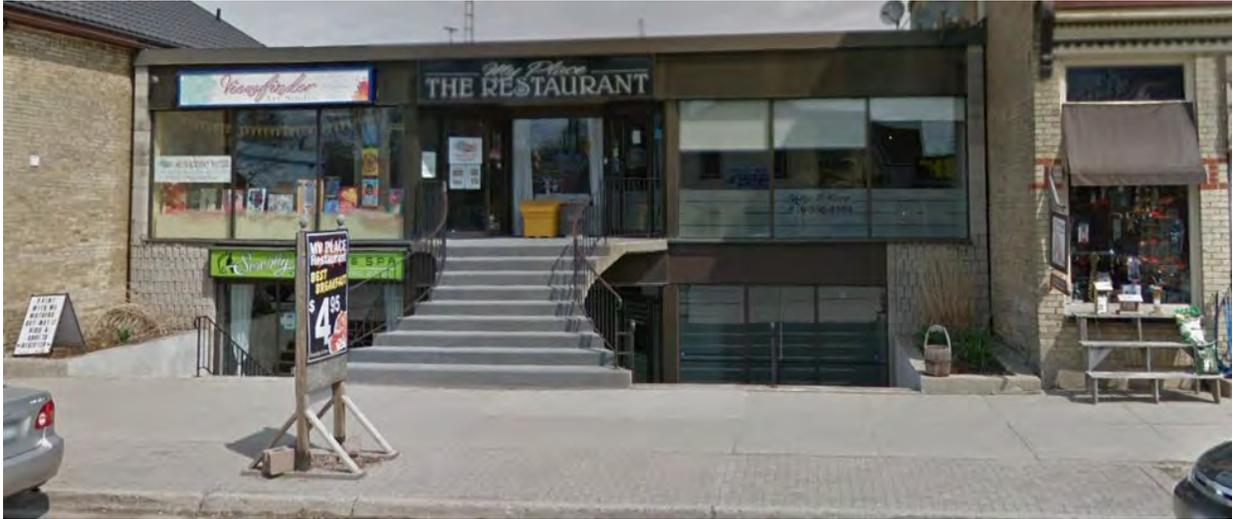
In Graphic M, due to the lower level restaurant, the first-floor elevation was set as mean ground surface minus the number of steps. Similarly, in Graphic N, as apartment buildings also do not include basements, the first-floor elevation was set at mean ground surface minus the number of steps. In Graphic O, due to the lower level, first-floor elevation was set as minimum ground surface.

Graphic M Special Case: Set First-floor Elevation as Mean Ground Surface Minus Number of Steps

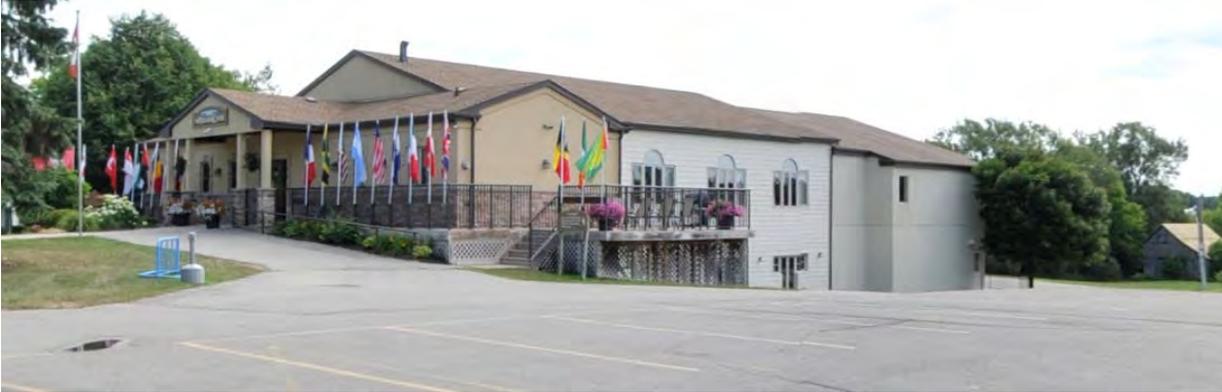
Graphic O Special Case: Set First-floor Elevation as Minimum Ground Surface

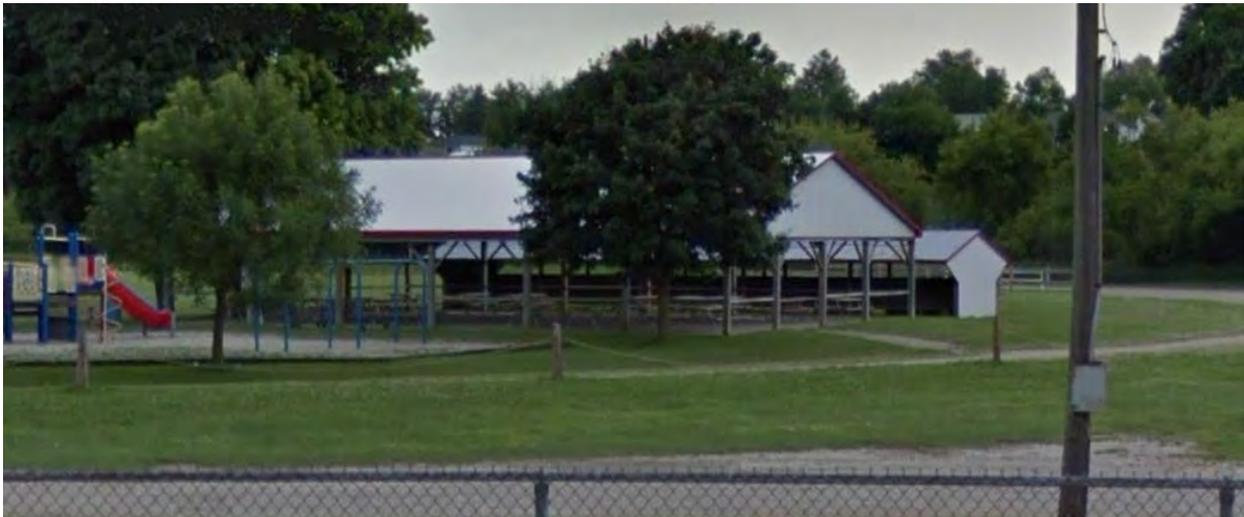
Special consideration was made for the two picnic shelters in the fair grounds (Graphic P). These two structures (Building ID 133190 and 133191) were included in the original buildings layer; however, as damages would be quite low and more in line with external sheds, which are already accounted for in the depth-damage curves for the other structures on the property, these two structures have been removed from the assessment. As these structures are within the 2-year floodplain, they are frequently flooded.

Graphic P Picnic Shelters in Fair Grounds
